Jardinette Apartments (HCM 390) 5128 Marathon St. Mills Act Historical Property Contract

Update Presentation to Cultural Heritage Commission 21 Sept 2023

Architects: Richard Neutra with Rudolf Schindler Built: 1928

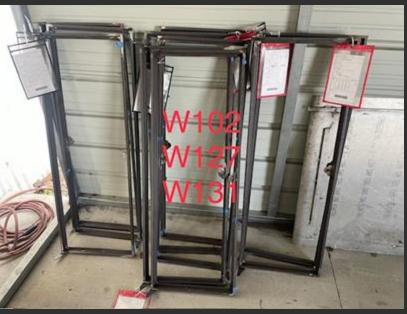
Original windows are intended to be restored as planned.

New steel windows to match existing as closely as possible, mocked up and approved by OHR, have been ordered for the entire front facade and are now in production, due to be delivered at the end of November 2023. Possible alternated for other facades to be discussed with OHR in near future.

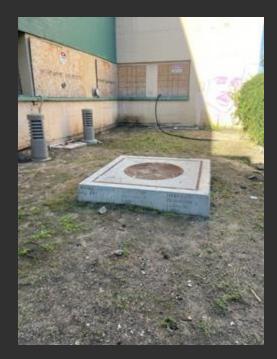
DWP transformer vault, fully installed

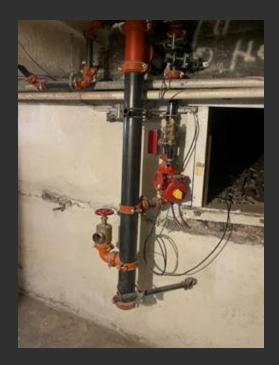
Fire Sprinkler manifold example system almost fully installed

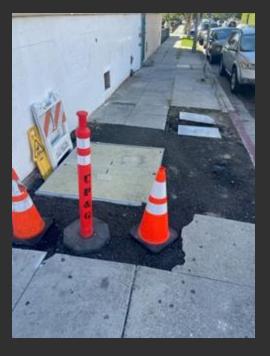
New water service / meter, fully installed

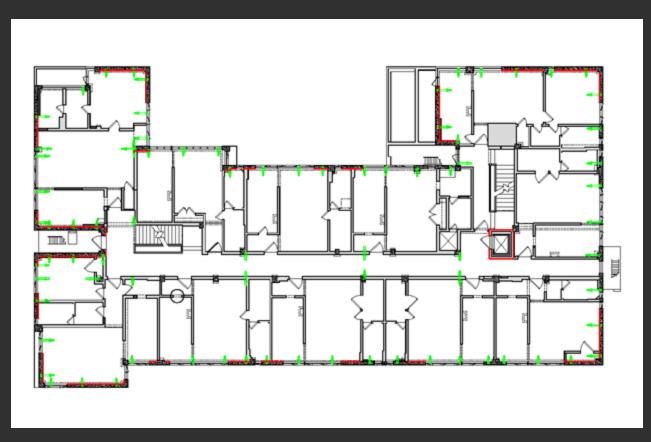
Diagrammatic plan showing partial structural upgrades – voluntary upgrades address known significant structural deficiencies with no visible impact to the historic fabric

There are 4 major components to the retrofit, to be completed to the extent feasible.

1)Out of Plane Anchors: Anchoring the wood diaphragm to the concrete shell (anchors shown in GREEN). Epoxy connections will not be expressed on exterior façade.

1)Diaphragm Strengthening: Re-sheathing the floor diaphragm to gain proper strength

1)Concrete Strengthening: Fiber-Wrap the concrete shell (from the inside – locations shown in RED) to supplement existing rebar

1)Foundation work, currently in process.

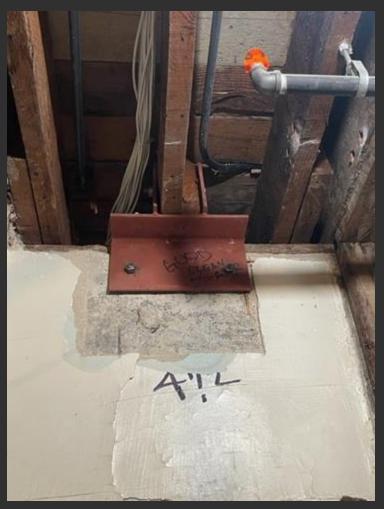
Example of anchor placed on interior wall

It was determined after the full scope was priced out that the only feasible portion was step 1 – anchor bolting.

A permit was acquired for this work in 2022 (21016-10000-03703) and work was completed in June 2023, with the permit finaled.

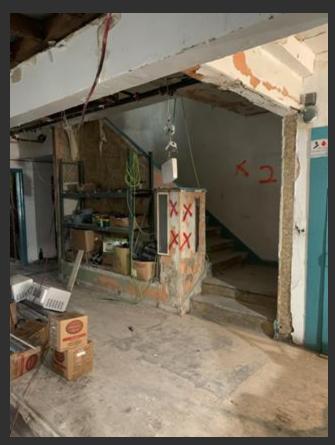
The original stair shaft has been opened up and the bench and light has been exposed (X means SAVE)

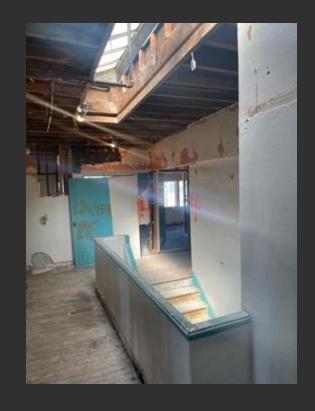
Non-original shaft enclosure in the Lobby was removed but LAFD did not allow the removal of elements in the rear stair Skylight (shown above) has been cleaned up

The texture change was original, but the exact material was not and has been stripped. Most walls have been stripped, with the knowledge of OHR.

The fire sprinkler has been almost entirely installed.

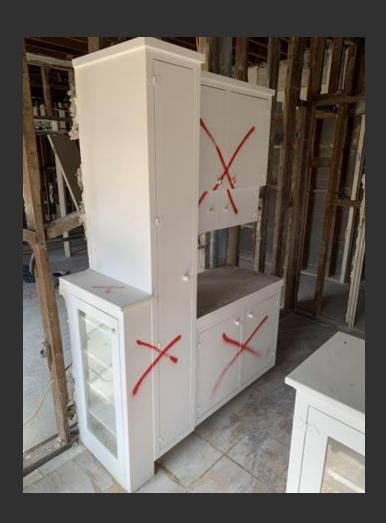
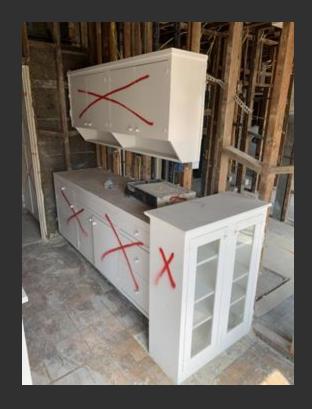
This is a newly-built cabinet designed to match original, done as a test. Original cabinetry for 2 full units have been saved and all the rest will be new to match.

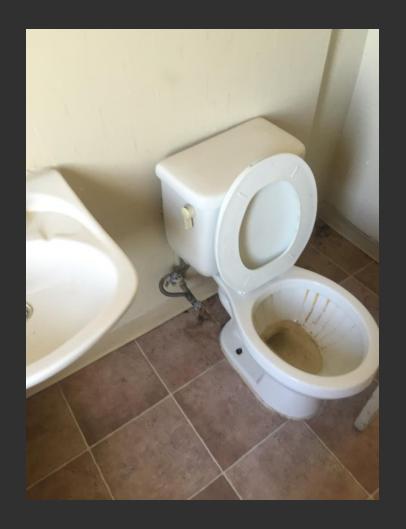
Views of very tight, non-original Bathroom in Unit 409 to be modified

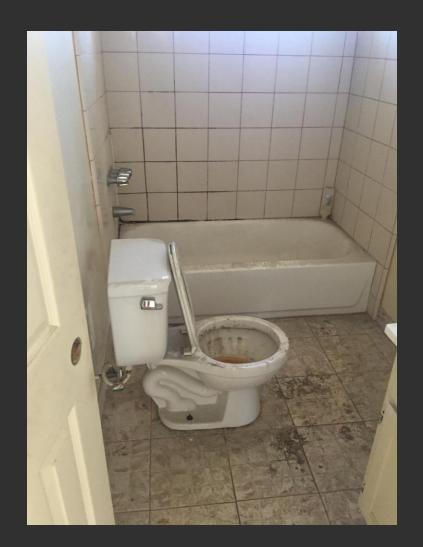
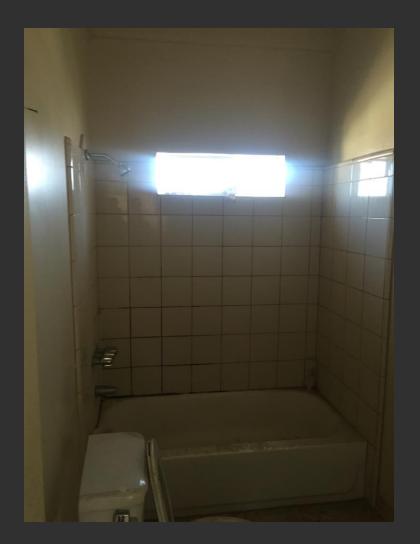
Views of non-original Bathroom in Unit 410 to be modified
